Burton in Kendal

Flood Investigation Report

**Flood Events 12th September 2017
and 22nd November 2017**

This flood investigation report has been produced by Cumbria County Council as a Lead Local Flood Authority under Section 19 of the Flood and Water Management Act 2010.

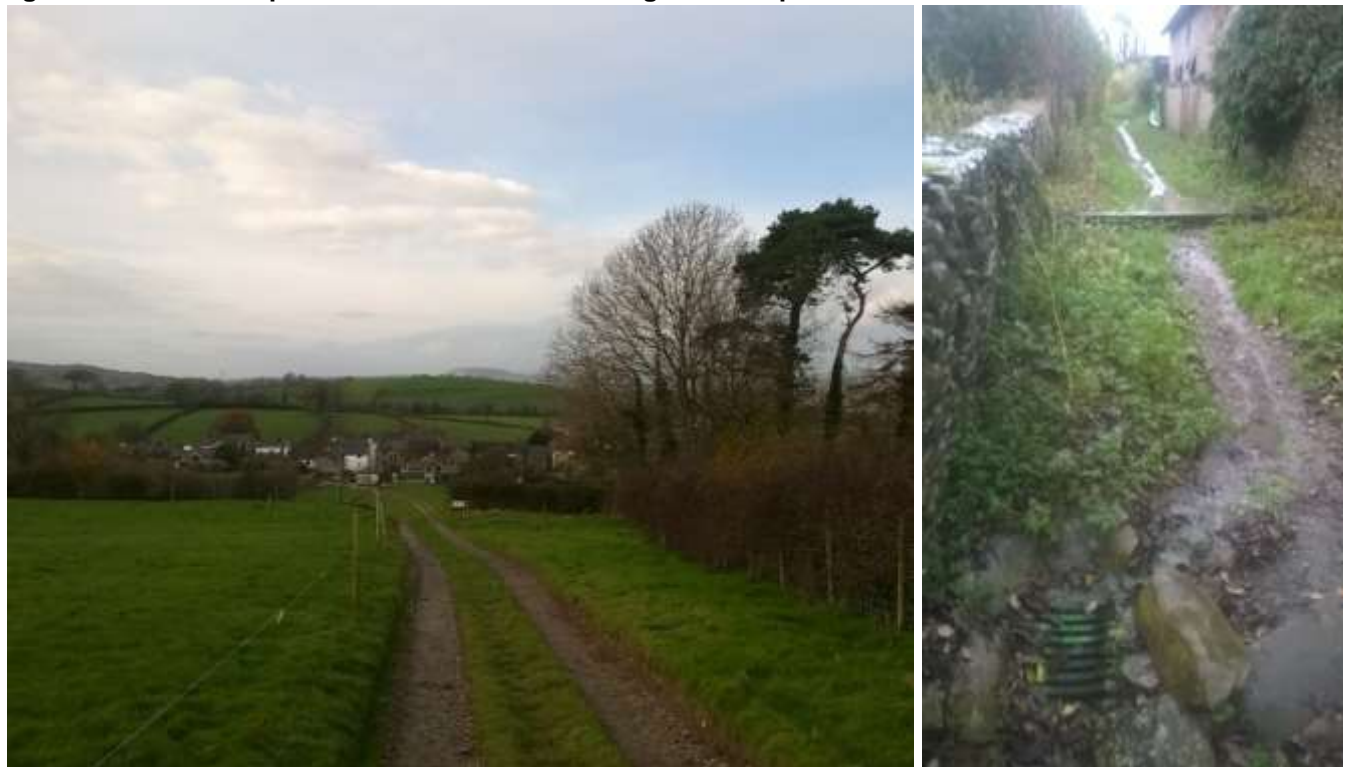
Figure 7 (left): Farm land above Main Street from the crest.

Figure 8 (right): Post Office Lane/Boon Town Lane path leading to gully on top of culverted watercourse.

Excess surface water flowed down from the squeeze style at the top of the Post Office Lane/Boon Town Lane path like a waterfall. Photographs show that the footpath is heavily scoured indicating significant flow. There appears to be a capacity issue for the pipe work under the path and poor interception form the surrounding land to the piped system. Fig 8 shows water passing the gull rather than being collected over the top of it.

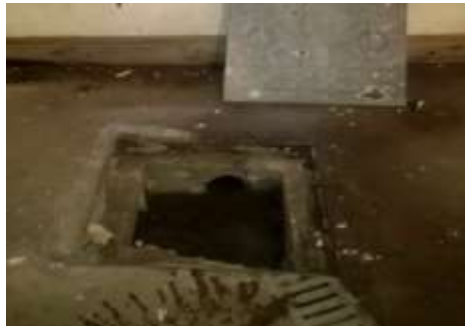
Properties on the east side of the square flooded by groundwater coming through the cellars. The cellars are designed with weep holes to let the groundwater into the cellars and a floor level drain to allow water to pass through. The cellar drains are below the level of the culvert so the cellars are thought to discharge to soakaways at the front of the properties although the destination remains unproven. The weep holes are said to have been spouting out like a fountain. Flooding in these cellars was 0.3m deep.

Figure 9: Cellar drain leading to manhole with a deeper drainage outlet which is below the level of the culvert so it is thought to lead to a soakaway.

| Cumbria Flood Partnership Theme | Action by | Recommended Action | Timescale |
|---|---|--|--|
| | Riparian owners | Investigate where cellar drainage is going at East side of The Square and repair/renew if necessary. | Ongoing |

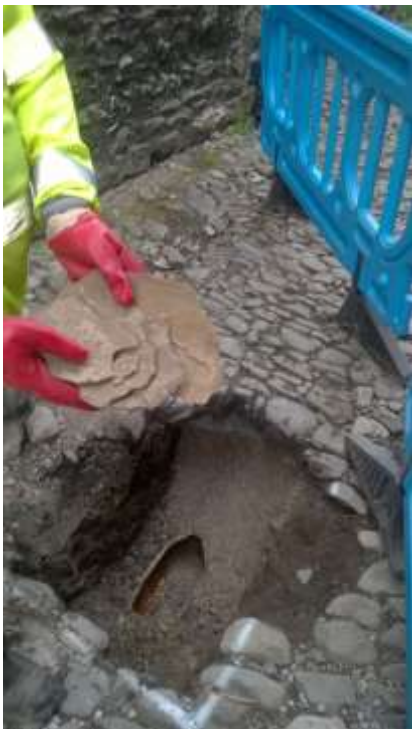
The road gullies discharge into the culverted watercourse under the square which had a number of problems. It was restricted by a grout like deposit set in layers making a smooth

pipe shaped deposit on the inside of the pipe. Similar deposits were found throughout the village which may indicate that this could be a feature of the local limestone geology. Services were found within the culvert under the square at three locations (gas pipe, a combined sewer, and two electricity cables) restricting flow. The culvert had also collapsed under The Square but this was repaired as soon as it was known.

Figure 11 (left): A grout like deposit was found to be lining the inside of the culvert pipes.
Figure 12 (right): A gas pipe crossing within the culvert barrel in The Square.

| | CCC Highways / Riparian owner | Investigate replacement or lining of all damaged culverts under adopted roads. | Ongoing |

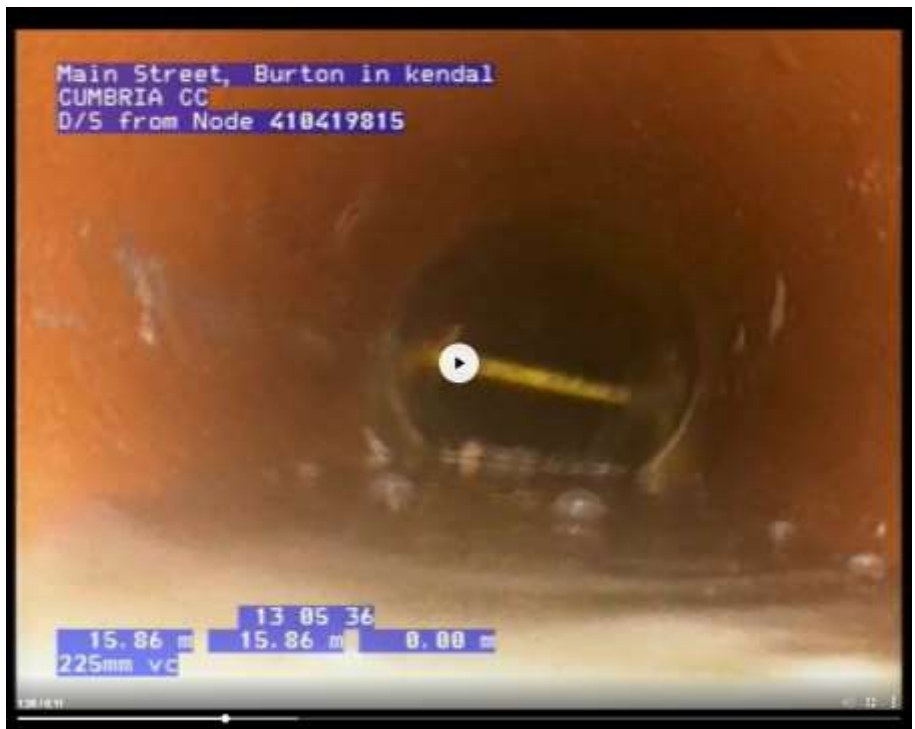
| Asset | Comment | Work Done |
|---|---|--|
| Ghost Node 371 | There is a gas pipe crossing within the barrel. Which has been marked up on the surface for removal by Cadent Gas. | |

| Cumbria Flood Partnership Theme | Action by | Recommended Action | Timescale |
|---|---|--|--|
| | Utilities Companies | Divert services outside of culvert barrel. | ENWL - Complete. Cadent Gas – Aug 2018 UU – Under review |

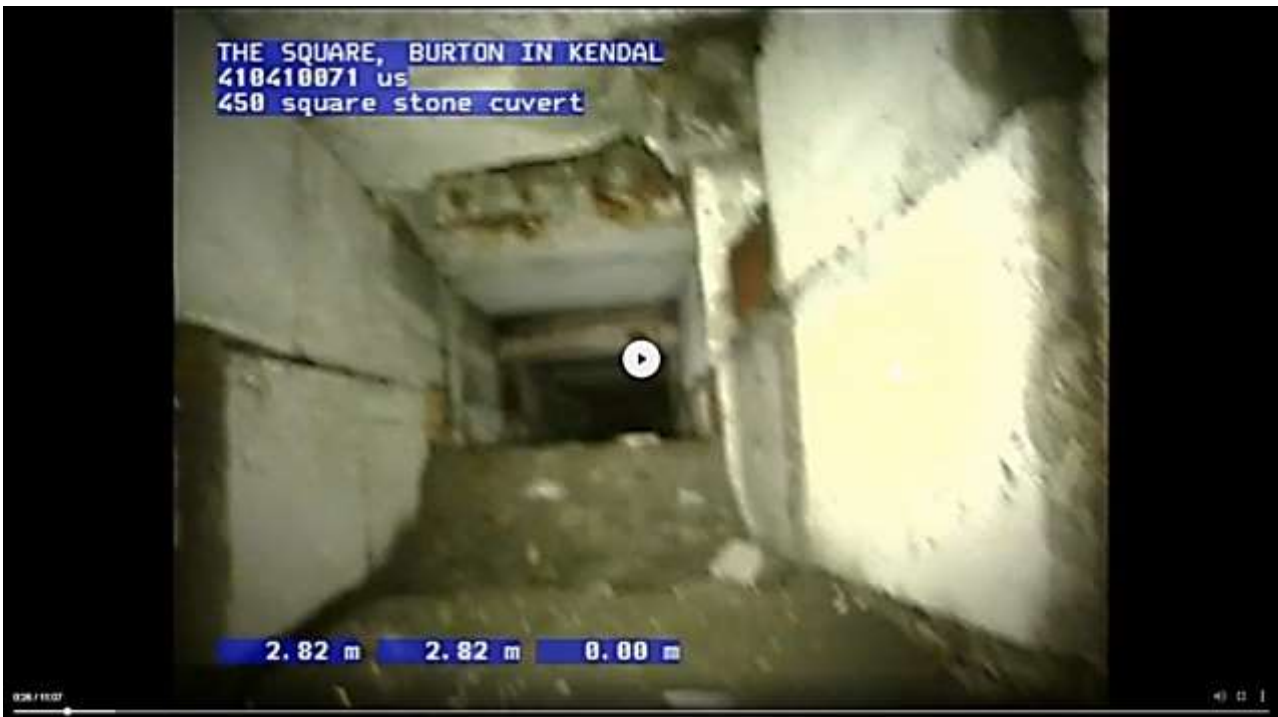
Figure 13: The combined sewer under Main Street crosses the culvert within the culvert barrel taking up approximately the bottom 150mm of the 450mm x 450mm culvert cross section.

| Asset | Comment | Work Done |
|---|---|---|
| Ghost node 811 | A pipe crosses the base of the culvert under this location. It is probably the combined sewer and takes up about 30%-50% of the cross sectional area. Culvert appears to be clear beyond the intruding pipe | |

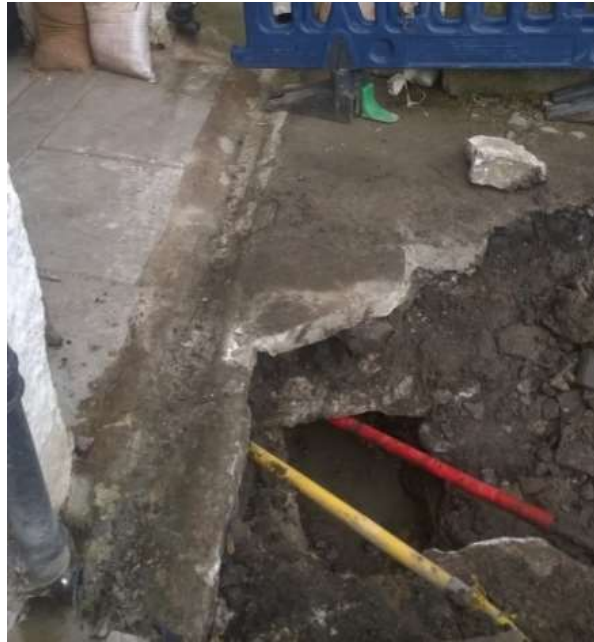
Figure 14 (right): Electricity cables in exposed culvert on 1/11/2017. Hole in the wall dropping onto the watercourse is visible behind barrier.

| Asset | Comment | Work Done |
|---|---|---|
| Stone Culvert 500 x 500 | This is where the electricity cables were within the culvert barrel which has been corrected by ENWL. Culvert is very irregular but no restriction to flow. | |

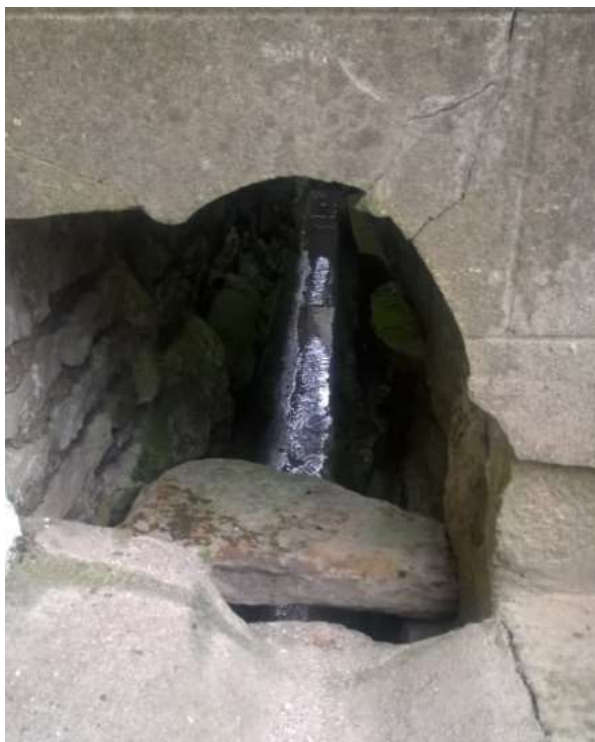
At the downstream side of the square there is an opening in the wall which allows surface water to flow through including the discharge of the main culvert below the discharge point. All flows reaching this outlet point freely flowed away into the drainage system behind the Croft.

Figure 15 Hole in the wall dropping onto the watercourse.

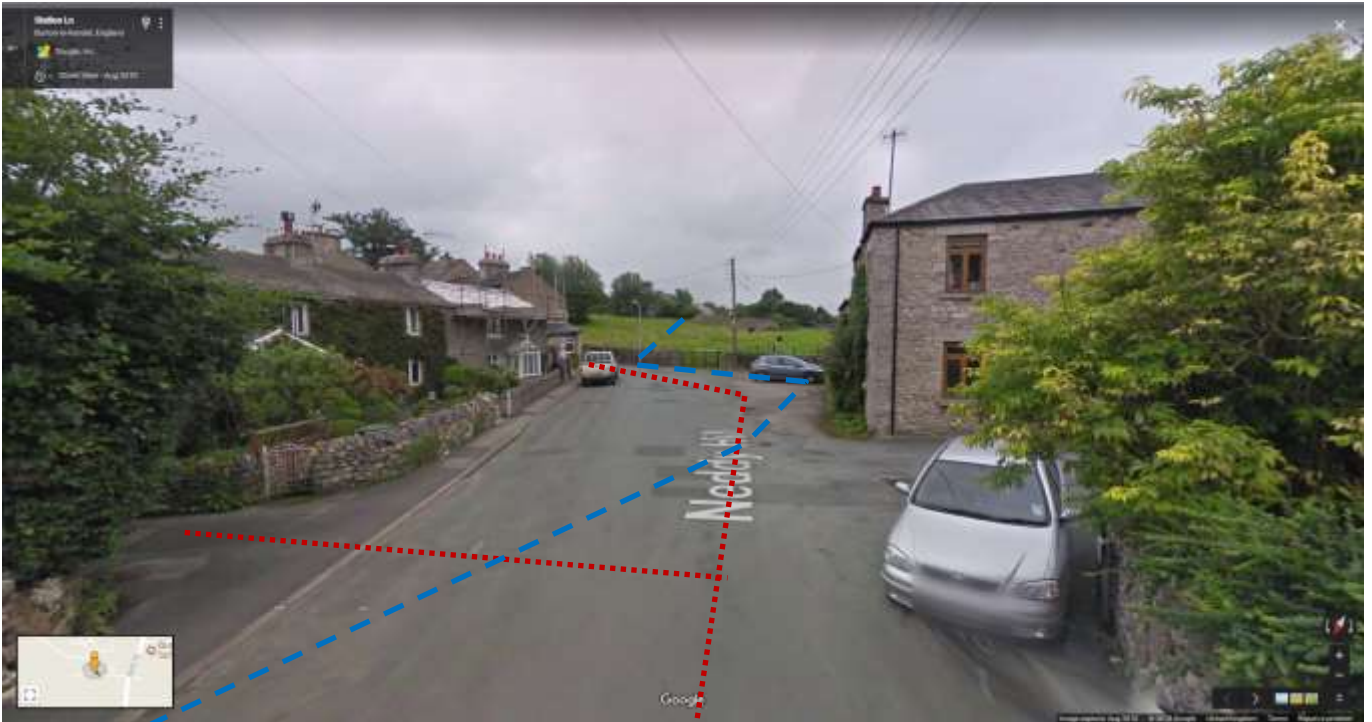
However, No 2, 3, and 4 Barker Terrace still flooded from backflows within the combined sewerage system which has at least 1 road gully connected to, household yard gullies and possibly infiltration from the damaged surface water culvert in the road. The residents of Barker Terrace have since carried out work to raise their yard gullies above the critical level to prevent exceedance by this route.

Figure 18: Barker Terrace on left with indicative line of culvert shown in blue and combined sewer in red.

| Cumbria Flood Partnership Theme | Action by | Recommended Action | Timescale |
|---|---|--|--|
| | United Utilities | Investigate whether there is a restriction in the combined sewer at Neddy Hill and/or whether a non return valve should be fitted. | Ongoing. |

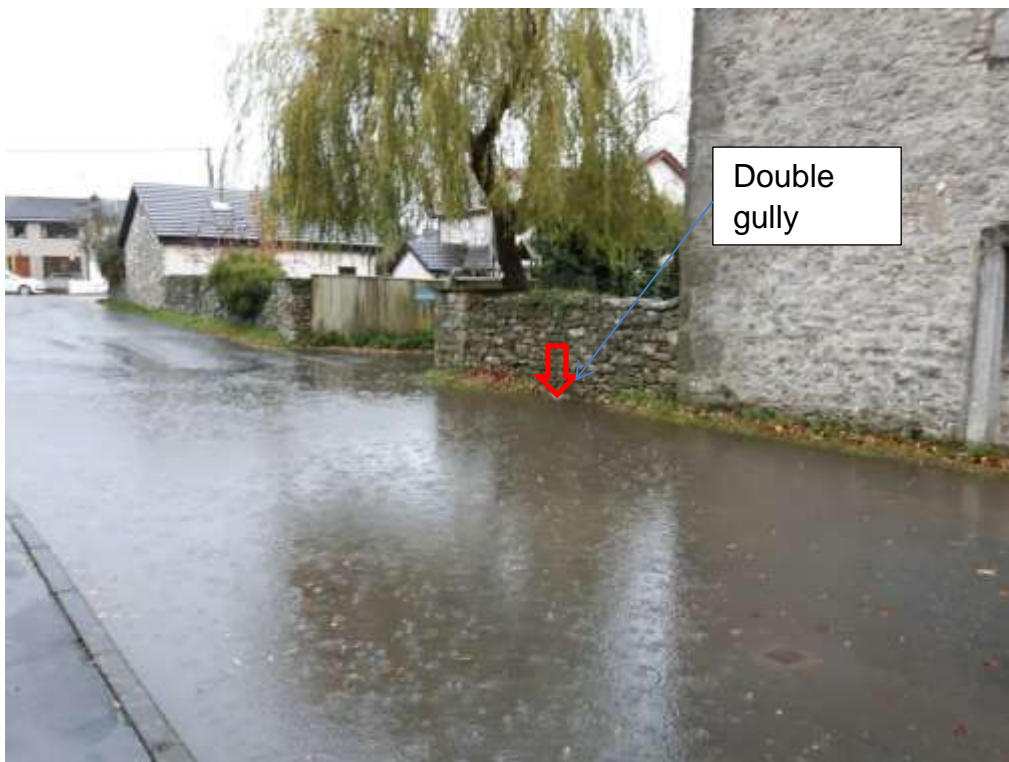
The watercourse continues northwards in a piped culvert under the gardens through to Burton Park where it drops onto another significant flow of water coming from the east. It then comes to an unusual double gully arrangement on Tanpits Lane outside The Tannery at the location indicated below.

Figure 19: Photo of the flooding on Tanpits Lane outside The Tannery. Location of double gully arrangement on culvert is indicated by red arrow.

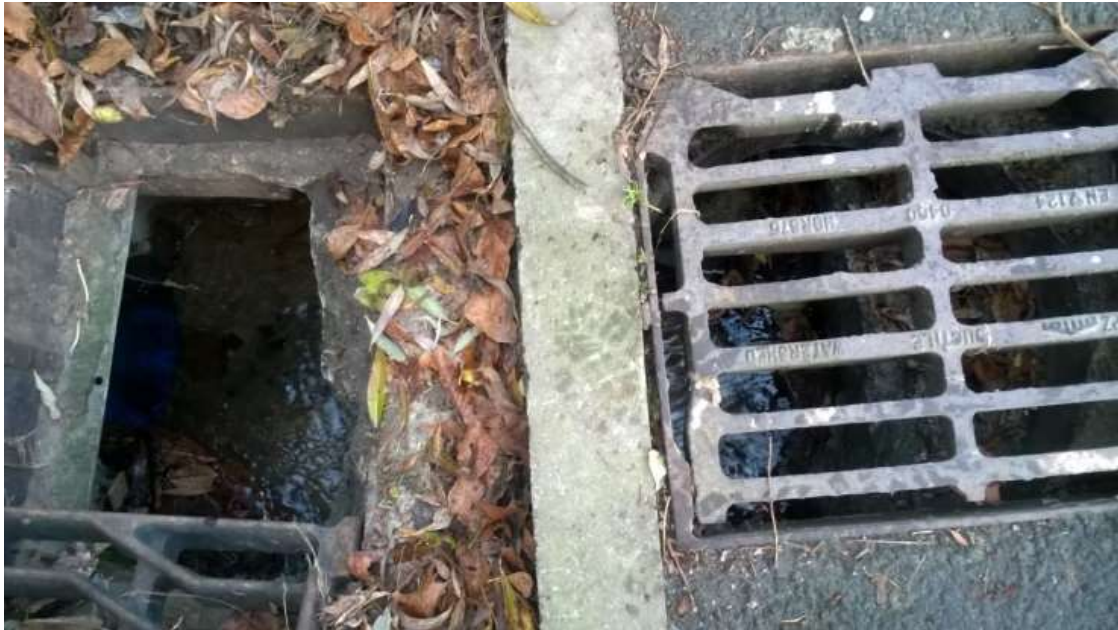
The two gullies share a chamber and the culvert comes in from the side rather than the straight through route. Connections come in from other gullies on Tanpits Lane and nearby roof drainage.

Figure 20: Photo of double gully arrangement on Tanpits Lane.

With all these drainage routes converging here this is a key location and the main line pipe size does increase from 225mm to 300mm diameter. The watercourse continues under the wall from the double gully arrangement and emerges in an open channel for a short while before dropping back into a culvert in the field behind the Tannery.

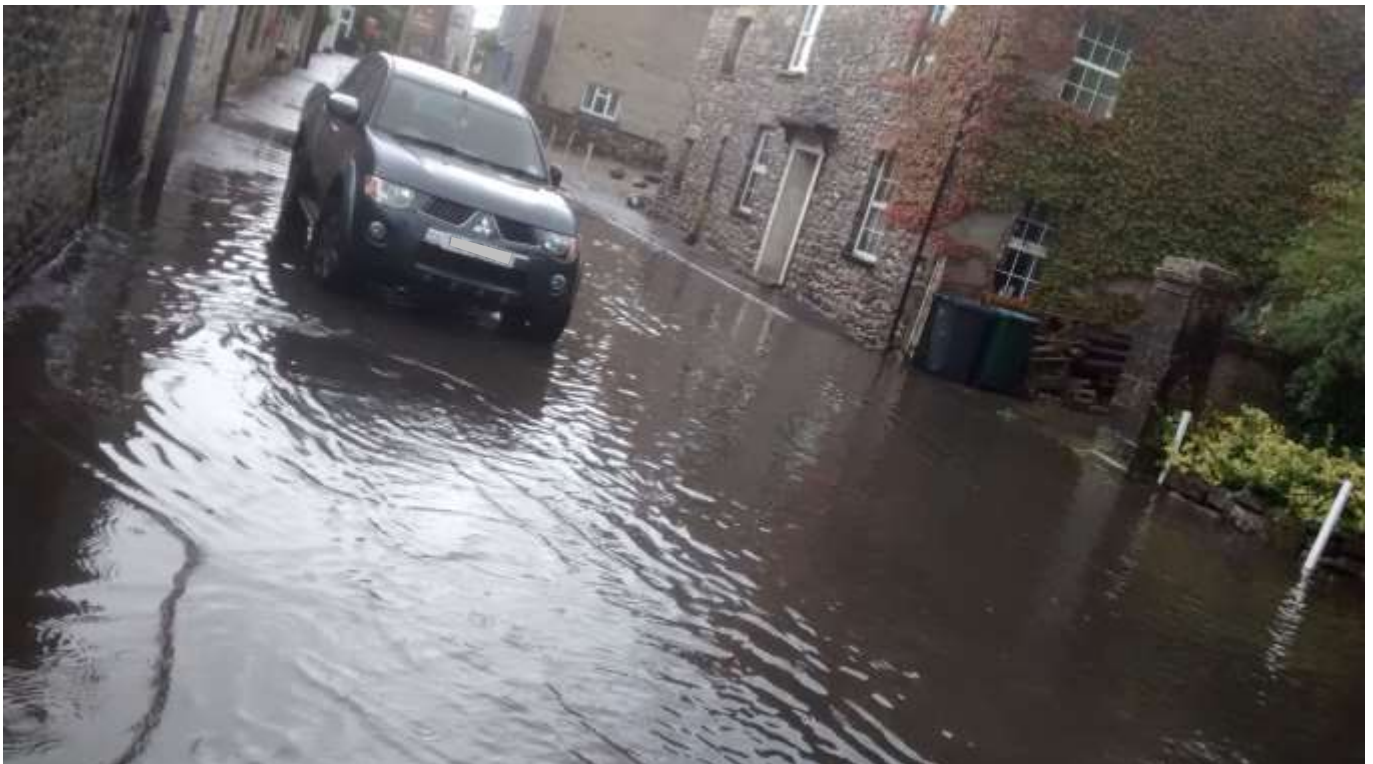
Road drainage is only designed to deal with rain water falling onto the road surface. It is not designed to drain fields. Consequently, road drainage is frequently overwhelmed by much more water than it is intended to convey.

Figure 22: Flooding on Main Street outside The Creamery

| | CCC Highways / Landowner | Consider upgrades to drainage system around The Creamery. | Ongoing |

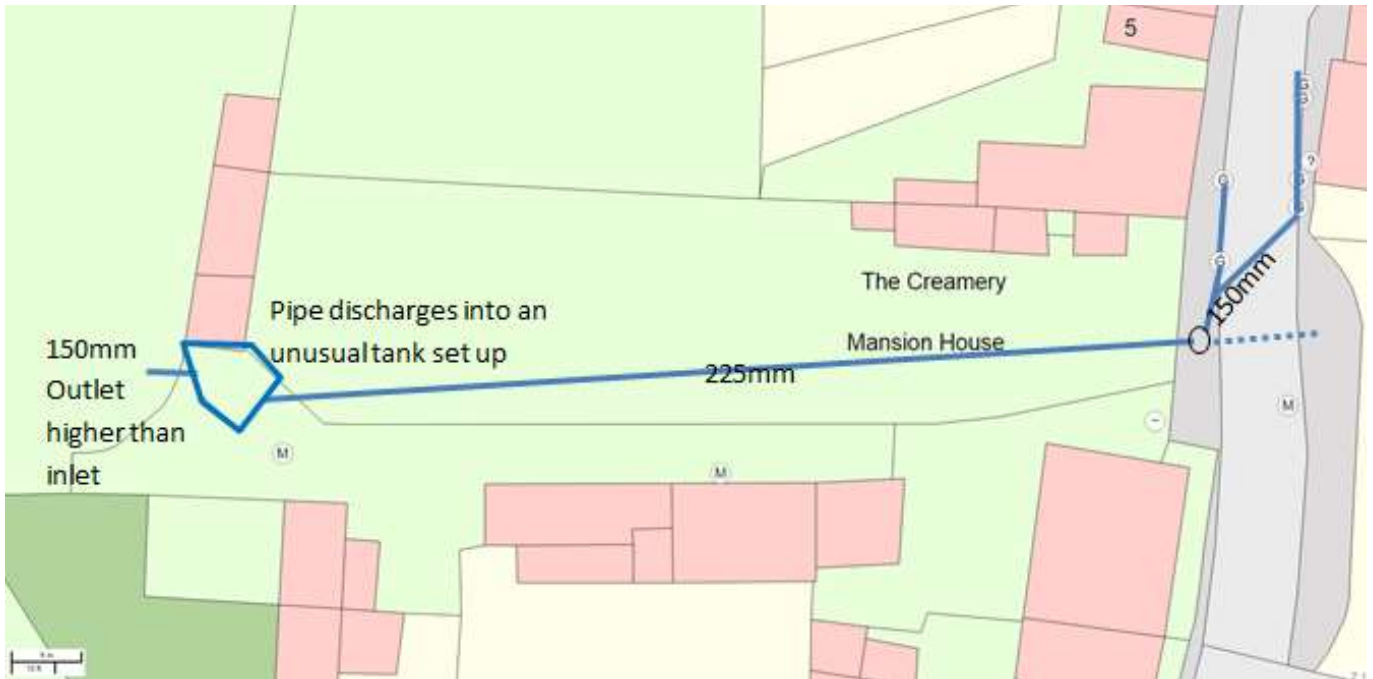
Figure 23: Below ground drainage serving Main Street near The Creamery.

There are five road gullies in the vicinity of The Creamery which all come together at one manhole which outfalls by a 150mm pipe to what used to be an old stone drain which has recently been replaced by Highways with a 225mm pipe. The pipes outfalls into a holding tank at the bottom of the track between The Creamery and the Mansion House. The holding tank has a 150mm diameter outlet set at a higher level than the 225mm inlet which discharges to the open field beyond where there is a soakaway as there is no known continuation of the drainage system. The field frequently floods and the flood water in the field has been observed to rise out of the ground, rather than flowing over the surface, which would correlate with a large input of water beneath the ground surface from a soakaway.

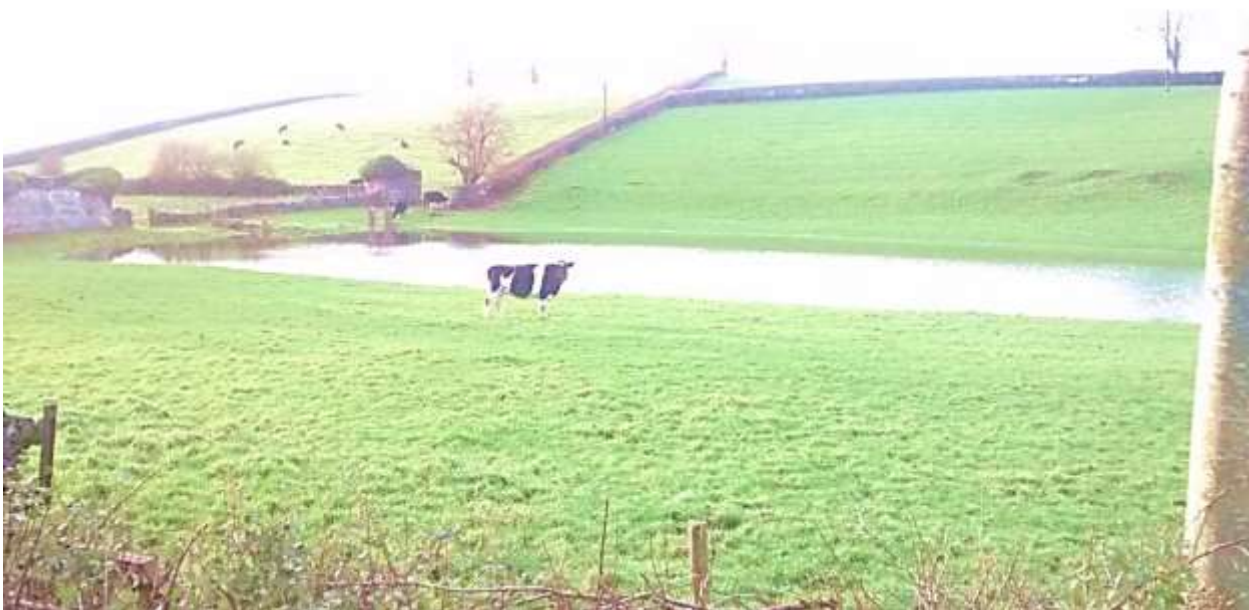
Figure 24: Flooding in field behind The Creamery on 18/6/2017.

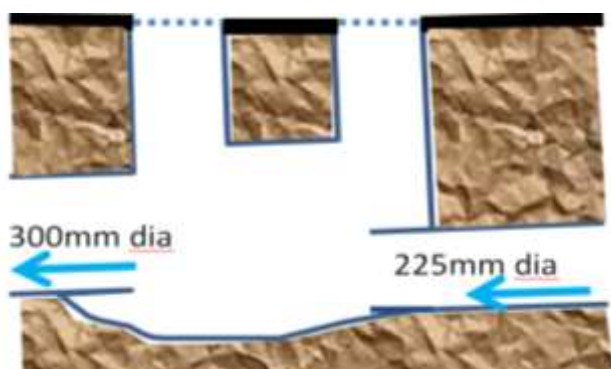
| Asset | Comment | Work Done |
|---|---|---|
| Double gully 251/275 | The Neddy Hill culvert comes in as a 225mm dia pipe on the left hand side (looking downstream) rather than what looks to be the main connection straight through the double gully. The connection is as good as blind because it is about 0.5m offset from the double gully and can't be reached. One of the inlets has an invert level 140mm below the invert level of the outlet. | |
