Burton in Kendal

Flood Investigation Report

**Flood Events 12th September 2017
and 22nd November 2017**

This flood investigation report has been produced by Cumbria County Council as a Lead Local Flood Authority under Section 19 of the Flood and Water Management Act 2010.

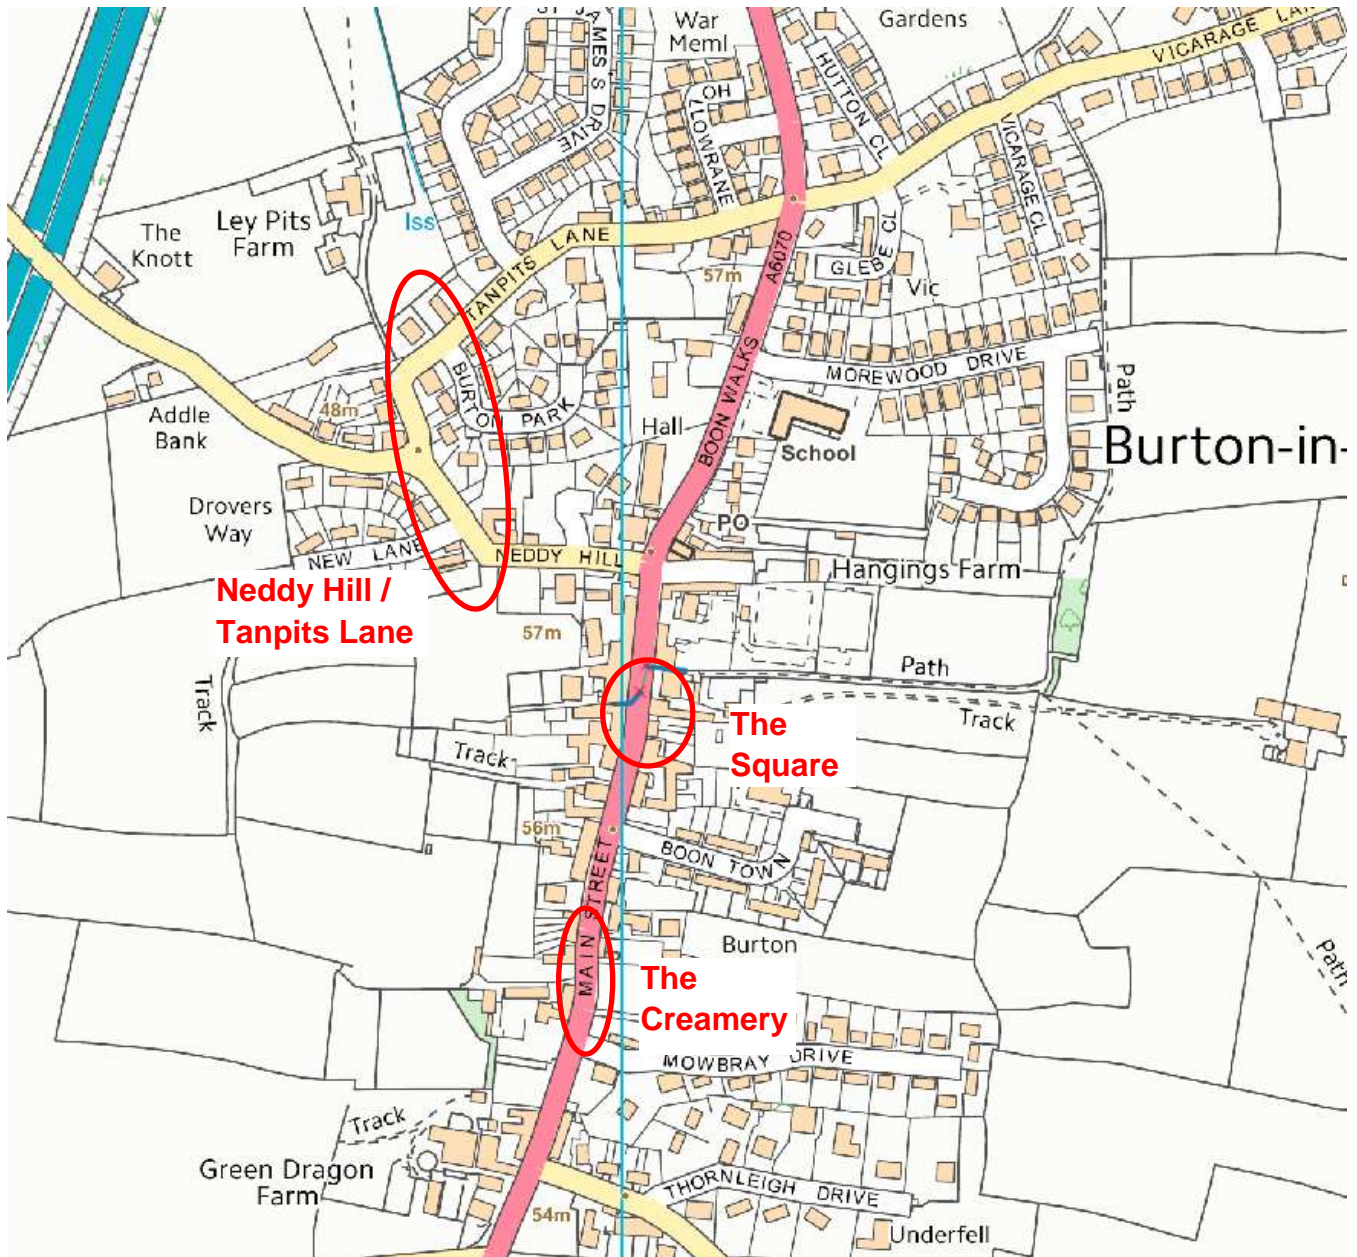
Figure 1: Main flood areas circled.

On 12th September 2017 12 properties were flooded internally at The Square, 1 property was flooded at The Creamery, and 1 property was flooded at Neddy Hill/Tanpits Lane (3 further properties here were saved by sandbagging by residents). On 22nd November 2017, 3 properties were flooded internally at The Square, 1 property was flooded at The Creamery, and 1 property was flooded at Neddy Hill/Tanpits Lane (3 further properties here were saved by sandbagging by residents).

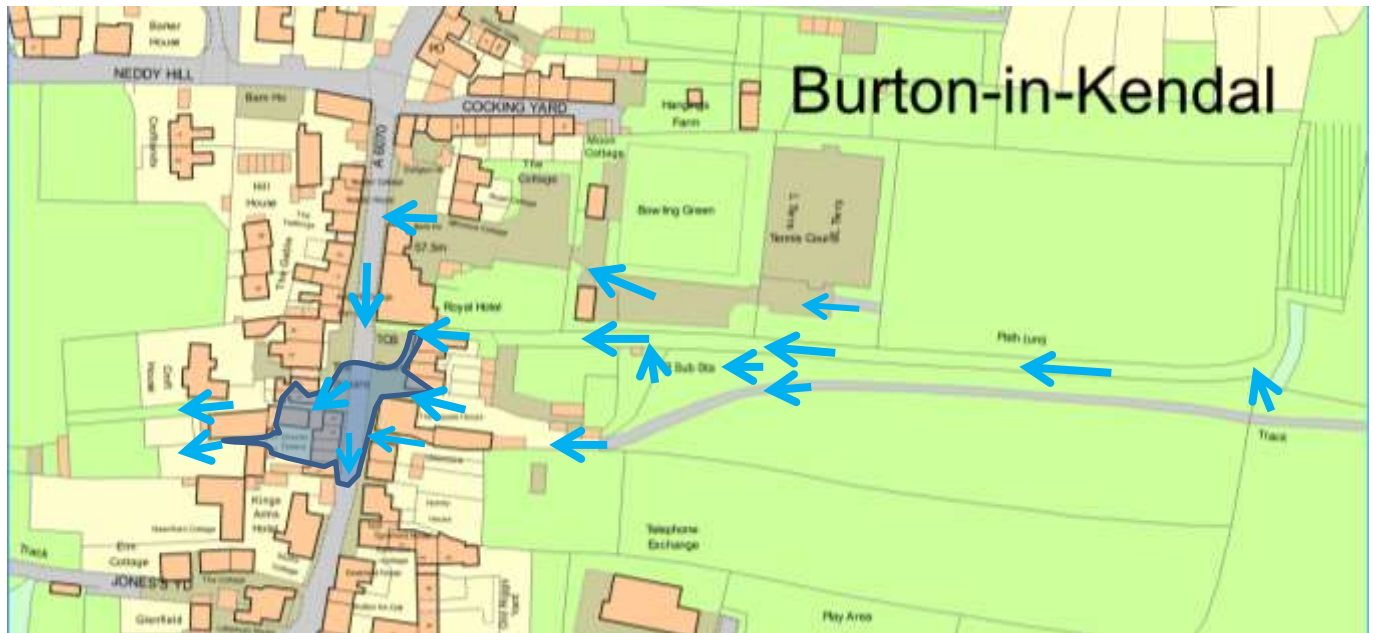
Figure 6: Seen and reported flow routes culminating at The Square.

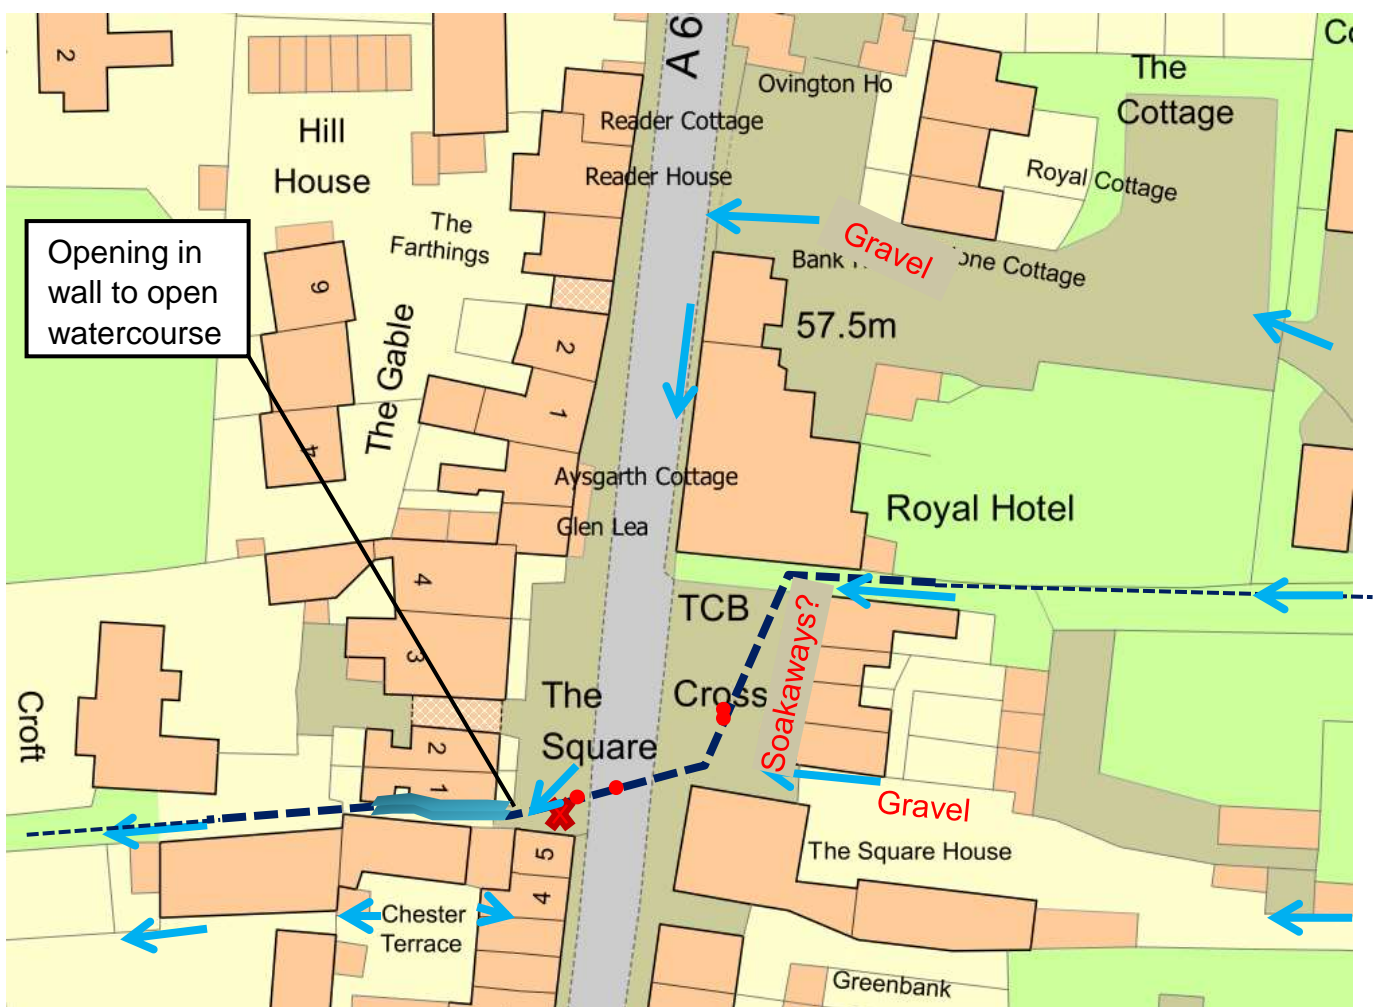
Figure 10. Culverts shown in dotted black line.

30m length of Main Street was flooded and the road gullies were not taking the flow away. The Square House had received cellar flooding but only flooded into the living areas of the house because of bow waves caused by traffic driving through the flooded road.

| Cumbria Flood Partnership Theme | Action by | Recommended Action | Timescale |
|---|---|--|--|
| Maintenance | CCC Highways | Repairs to all culverts affected by utilities. | Major repairs to culvert have been completed. Recent surveys are currently under review (July 2018). |

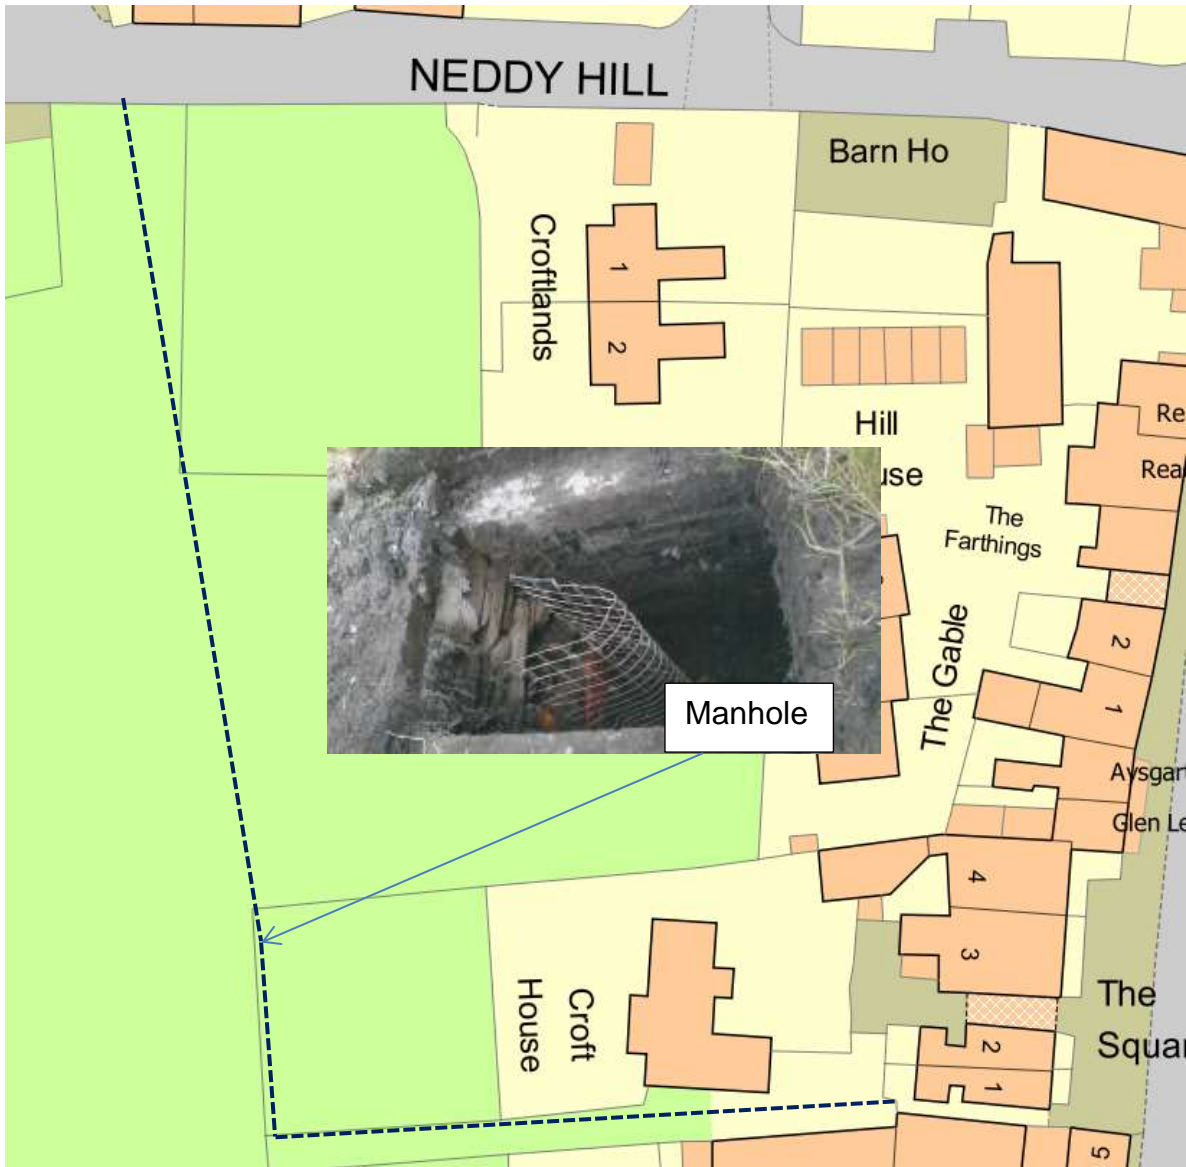
Figure 16: Charted route by highways in 2002 of drainage from The Square to NEDDY HILL.

Above is the route tracked by highways and an area of drainage that requires more investigation.

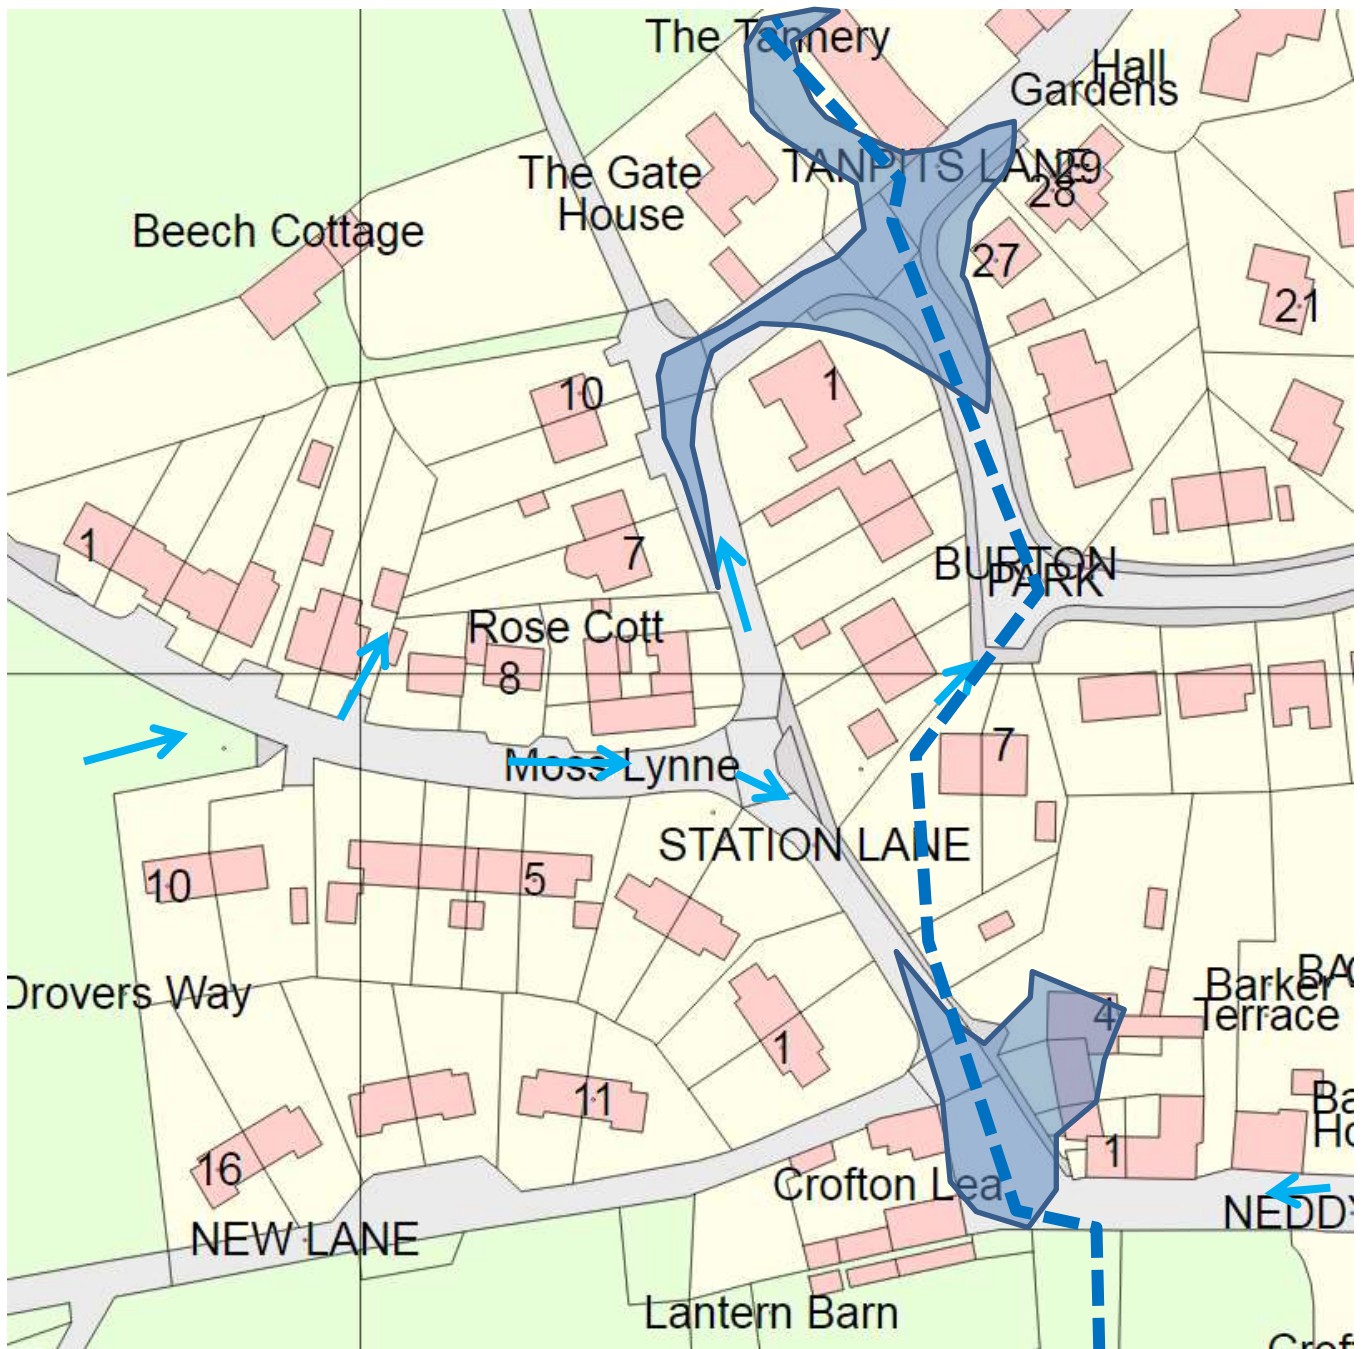
Figur 17 Neddy Hill and Tanpits Lane flooded areas

The increase in surface water from the storms and the restrictions within the culvert through the Neddy Hill led to backflow out of the highway gullies which are connected to it. The road is higher than the gardens of Barker Terrace but no runoff from the road can enter the gardens because of flood barriers installed after a previous near miss flood events.

However, No 2, 3, and 4 Barker Terrace still flooded from backflows within the combined sewerage system which has at least 1 road gully connected to, household yard gullies and possibly infiltration from the damaged surface water culvert in the road. The residents of Barker Terrace have since carried out work to raise their yard gullies above the critical level to prevent exceedance by this route.

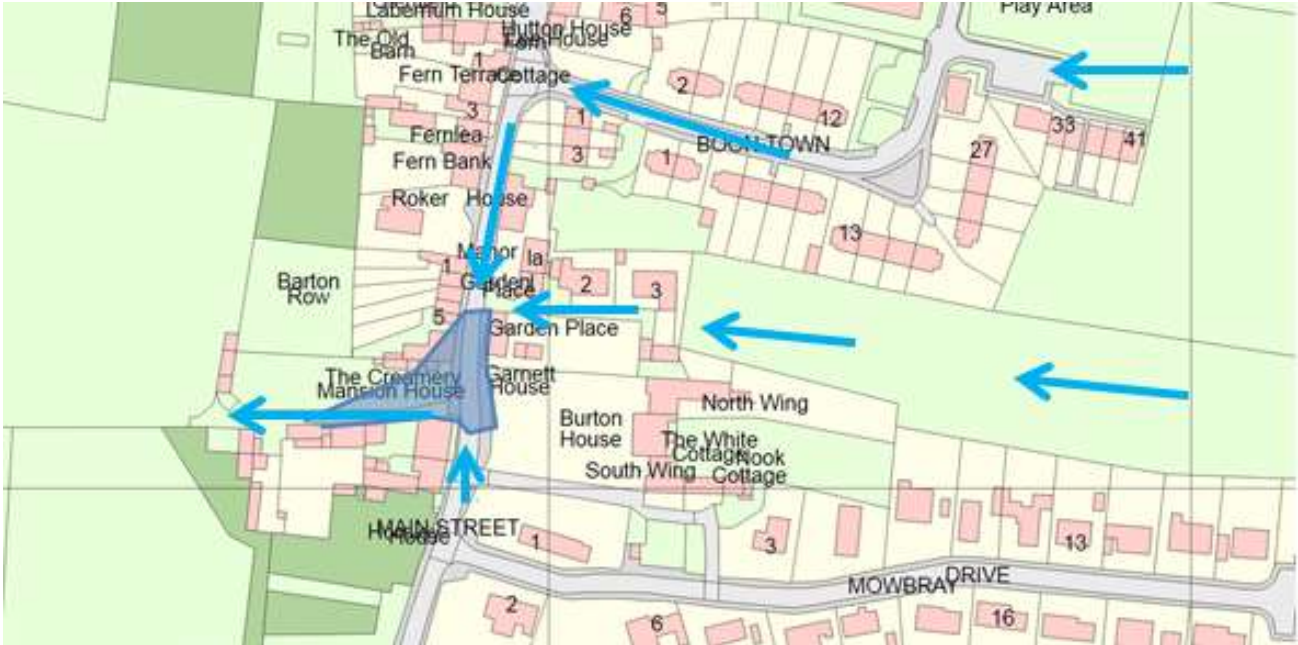
Surface water runoff from saturated ground above the area. Unlike The Square, there is no culvert to convey runoff east to west across Main Street in this area of the town so all surface runoff runs down side roads and alleyways converging on the lowest part of the road which is at The Creamery.

Figure 21: Reported flow routes and flooding at The Creamery

There are five road gullies in the vicinity of The Creamery which all come together at one manhole which outfalls by a 150mm pipe to what used to be an old stone drain which has recently been replaced by Highways with a 225mm pipe. The pipes outfalls into a holding tank at the bottom of the track between The Creamery and the Mansion House. The holding tank has a 150mm diameter outlet set at a higher level than the 225mm inlet which discharges to the open field beyond where there is a soakaway as there is no known continuation of the drainage system. The field frequently floods and the flood water in the field has been observed to rise out of the ground, rather than flowing over the surface, which would correlate with a large input of water beneath the ground surface from a soakaway.

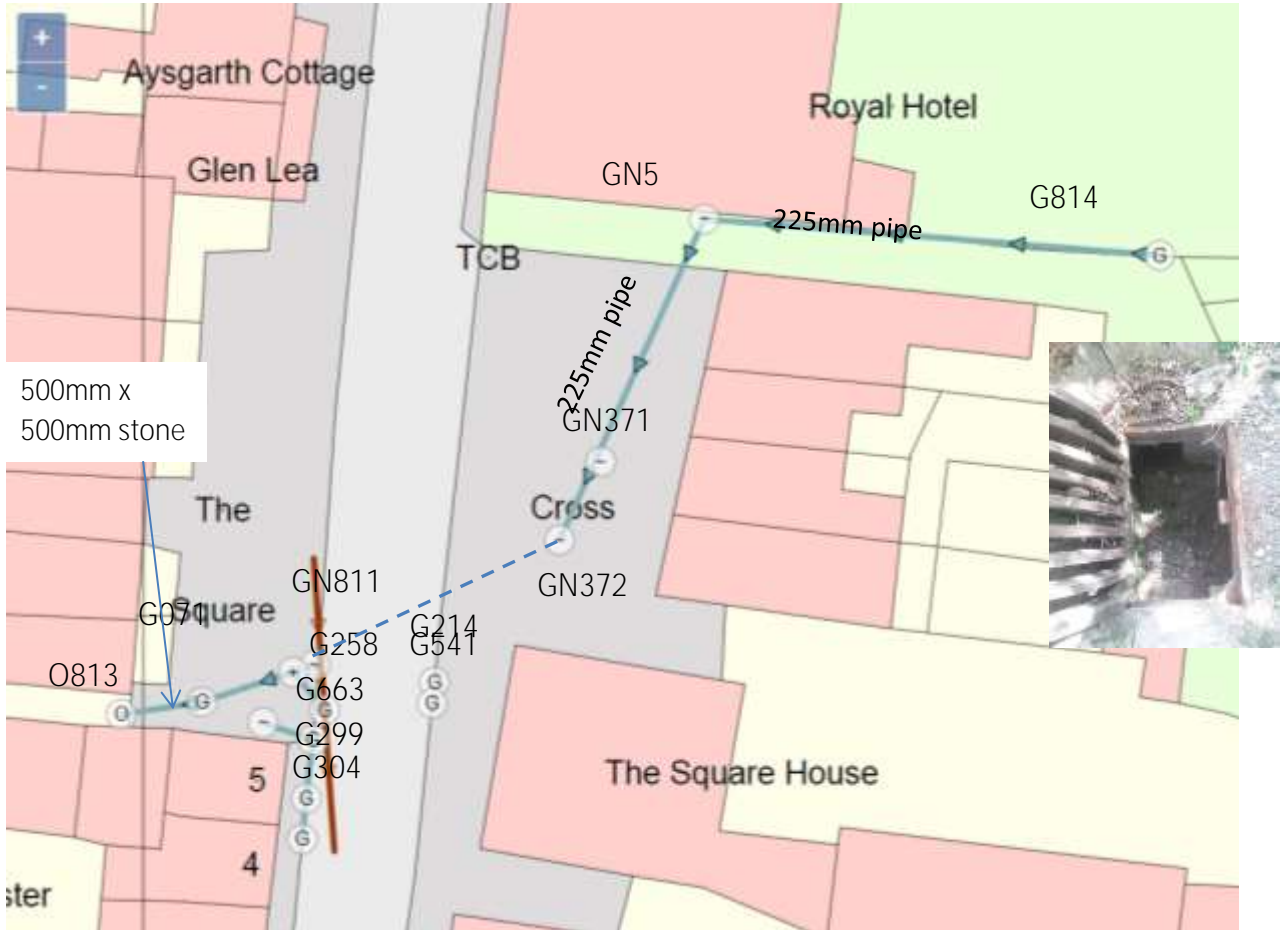
The Square Main Street

| Asset | Comment | Work Done |
|---|---|--|
| Gully 814 | Outflow is by 225mm dia clay pipe | |

| Asset | Comment | Work Done |
|---|---|---|
| Stone Culvert 500 x 500 | This is where the electricity cables were within the culvert barrel which has been corrected by ENWL. Culvert is very irregular but no restriction to flow. | |

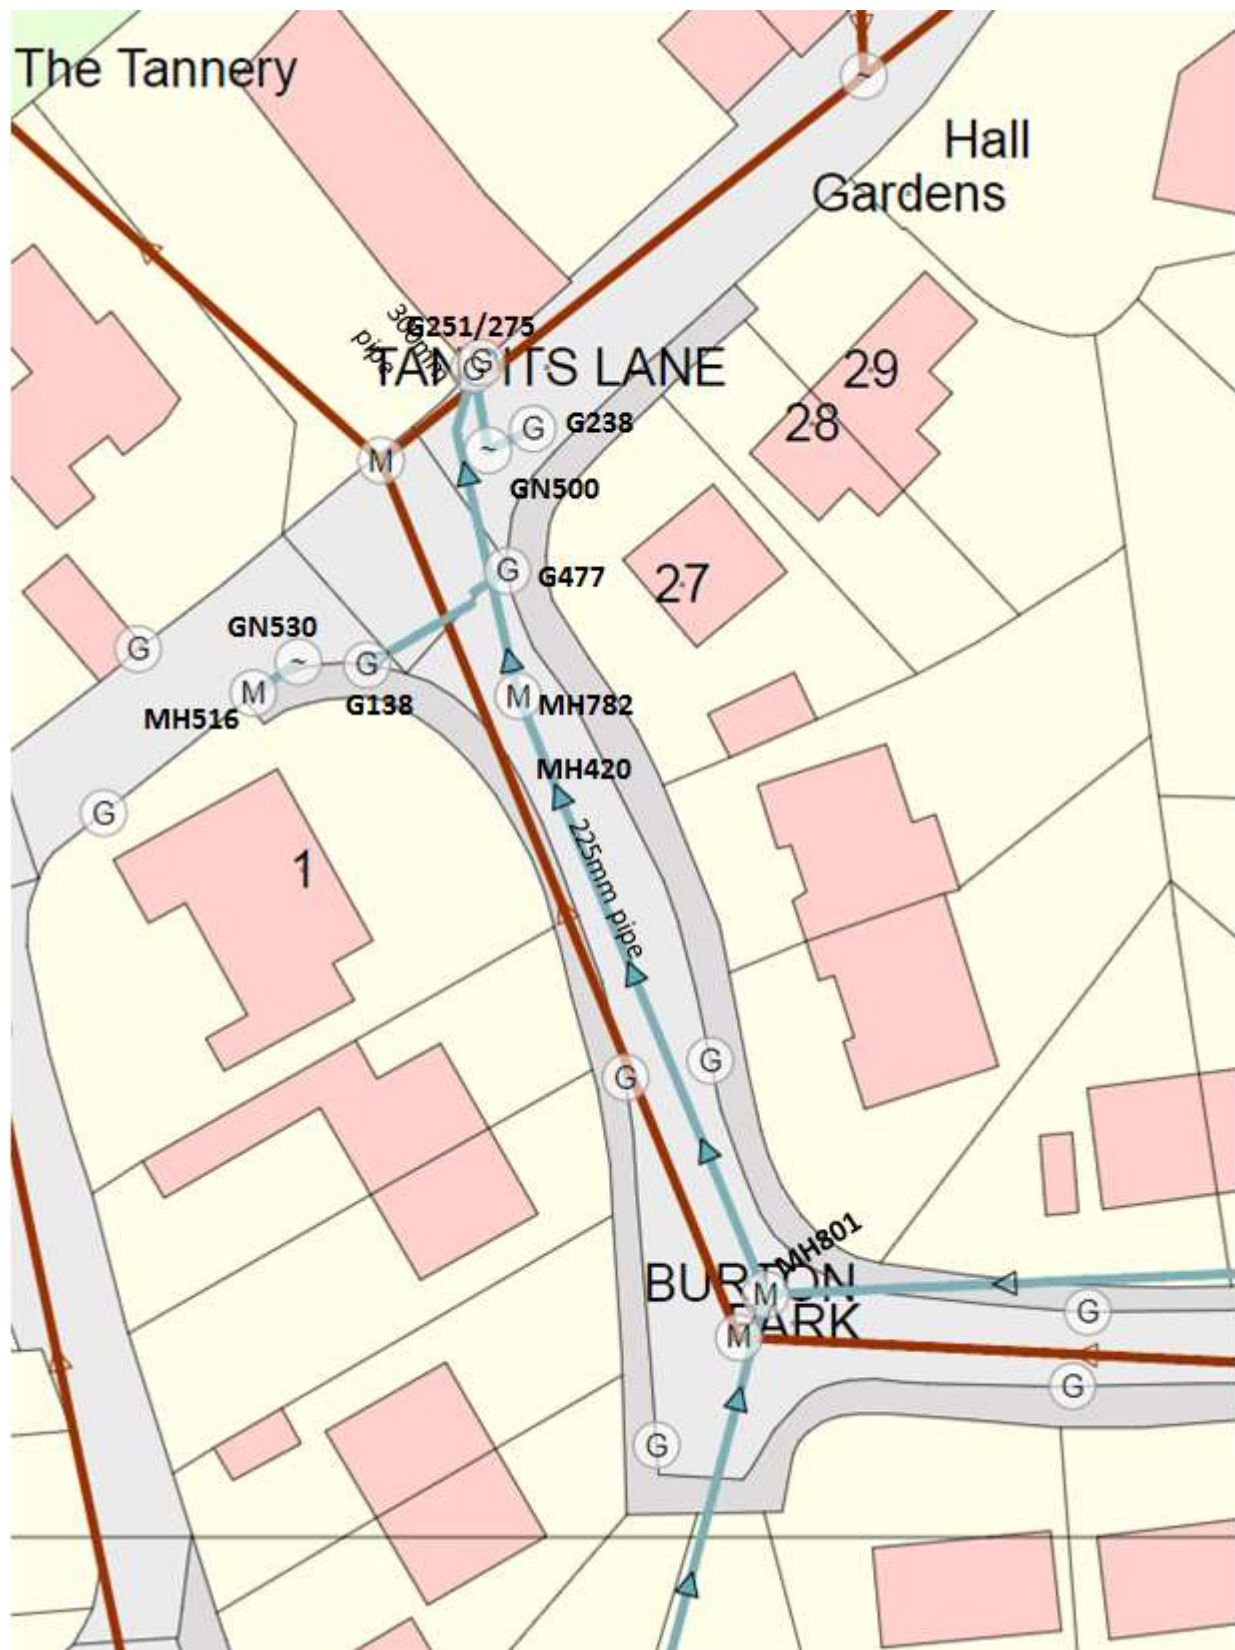
Tarnpits Lane

| Asset | Comment | Work Done |
|---|---|---|
| Manhole 782 | This is recorded as a UU asset and is the end of their line. They must view it as a watercourse from here onwards. There is grout in the base as has been found throughout Burton. An intruding connection prevents progress with the camera at 9m downstream. Dye testing proves the connection to the double gully 251/275 | |
